SUSTAINABLE ACCESS TO ELECTRICITY

Objectives

The general objective of this Monitoring & Evaluation activity is to elaborate lessons learned based on previous rural electrification programmes and issue recommendations 1) to maintain the electricity service of existing rural electrification systems and 2) to raise the sustainability of future programmes based on these findings.

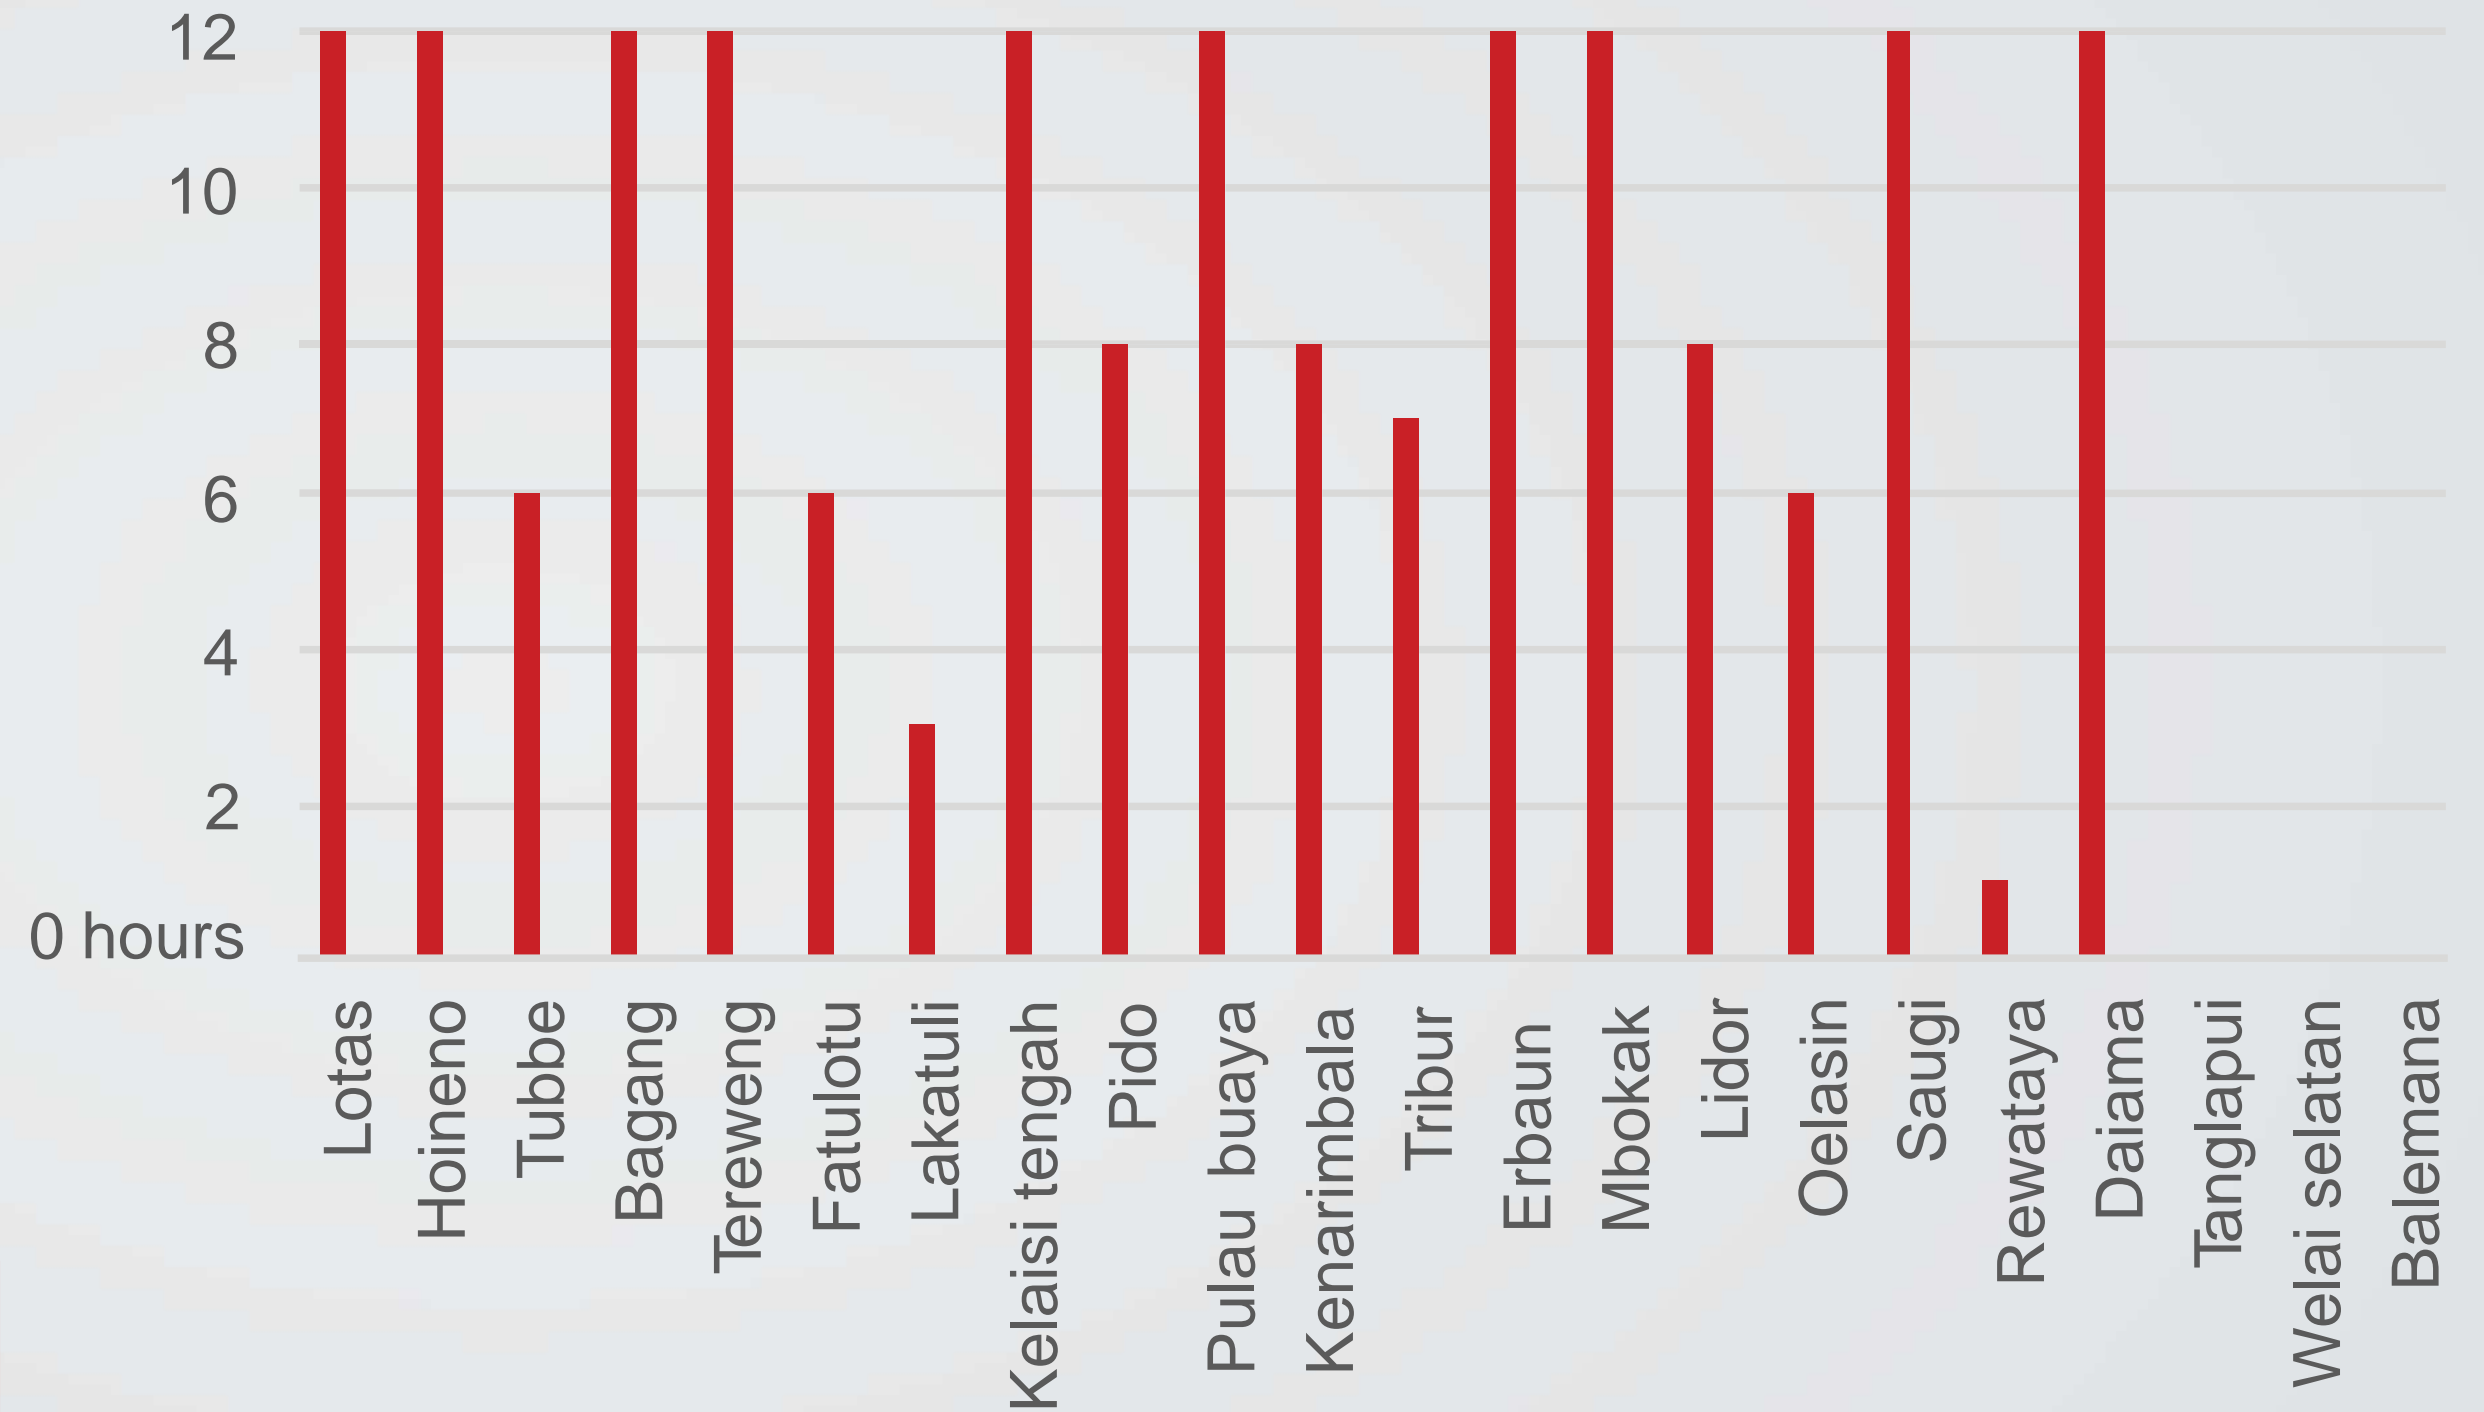
Benchmark of service
between 6 pm - 6 am (12 hours -> 24 hours)

- Ten locations (45%) served longer than 10 hours each day
- Five locations (23%) served up to 6 hours
- Four locations (18%) served between 6-10 hours
- Three mini-grid (14%) have stopped operating

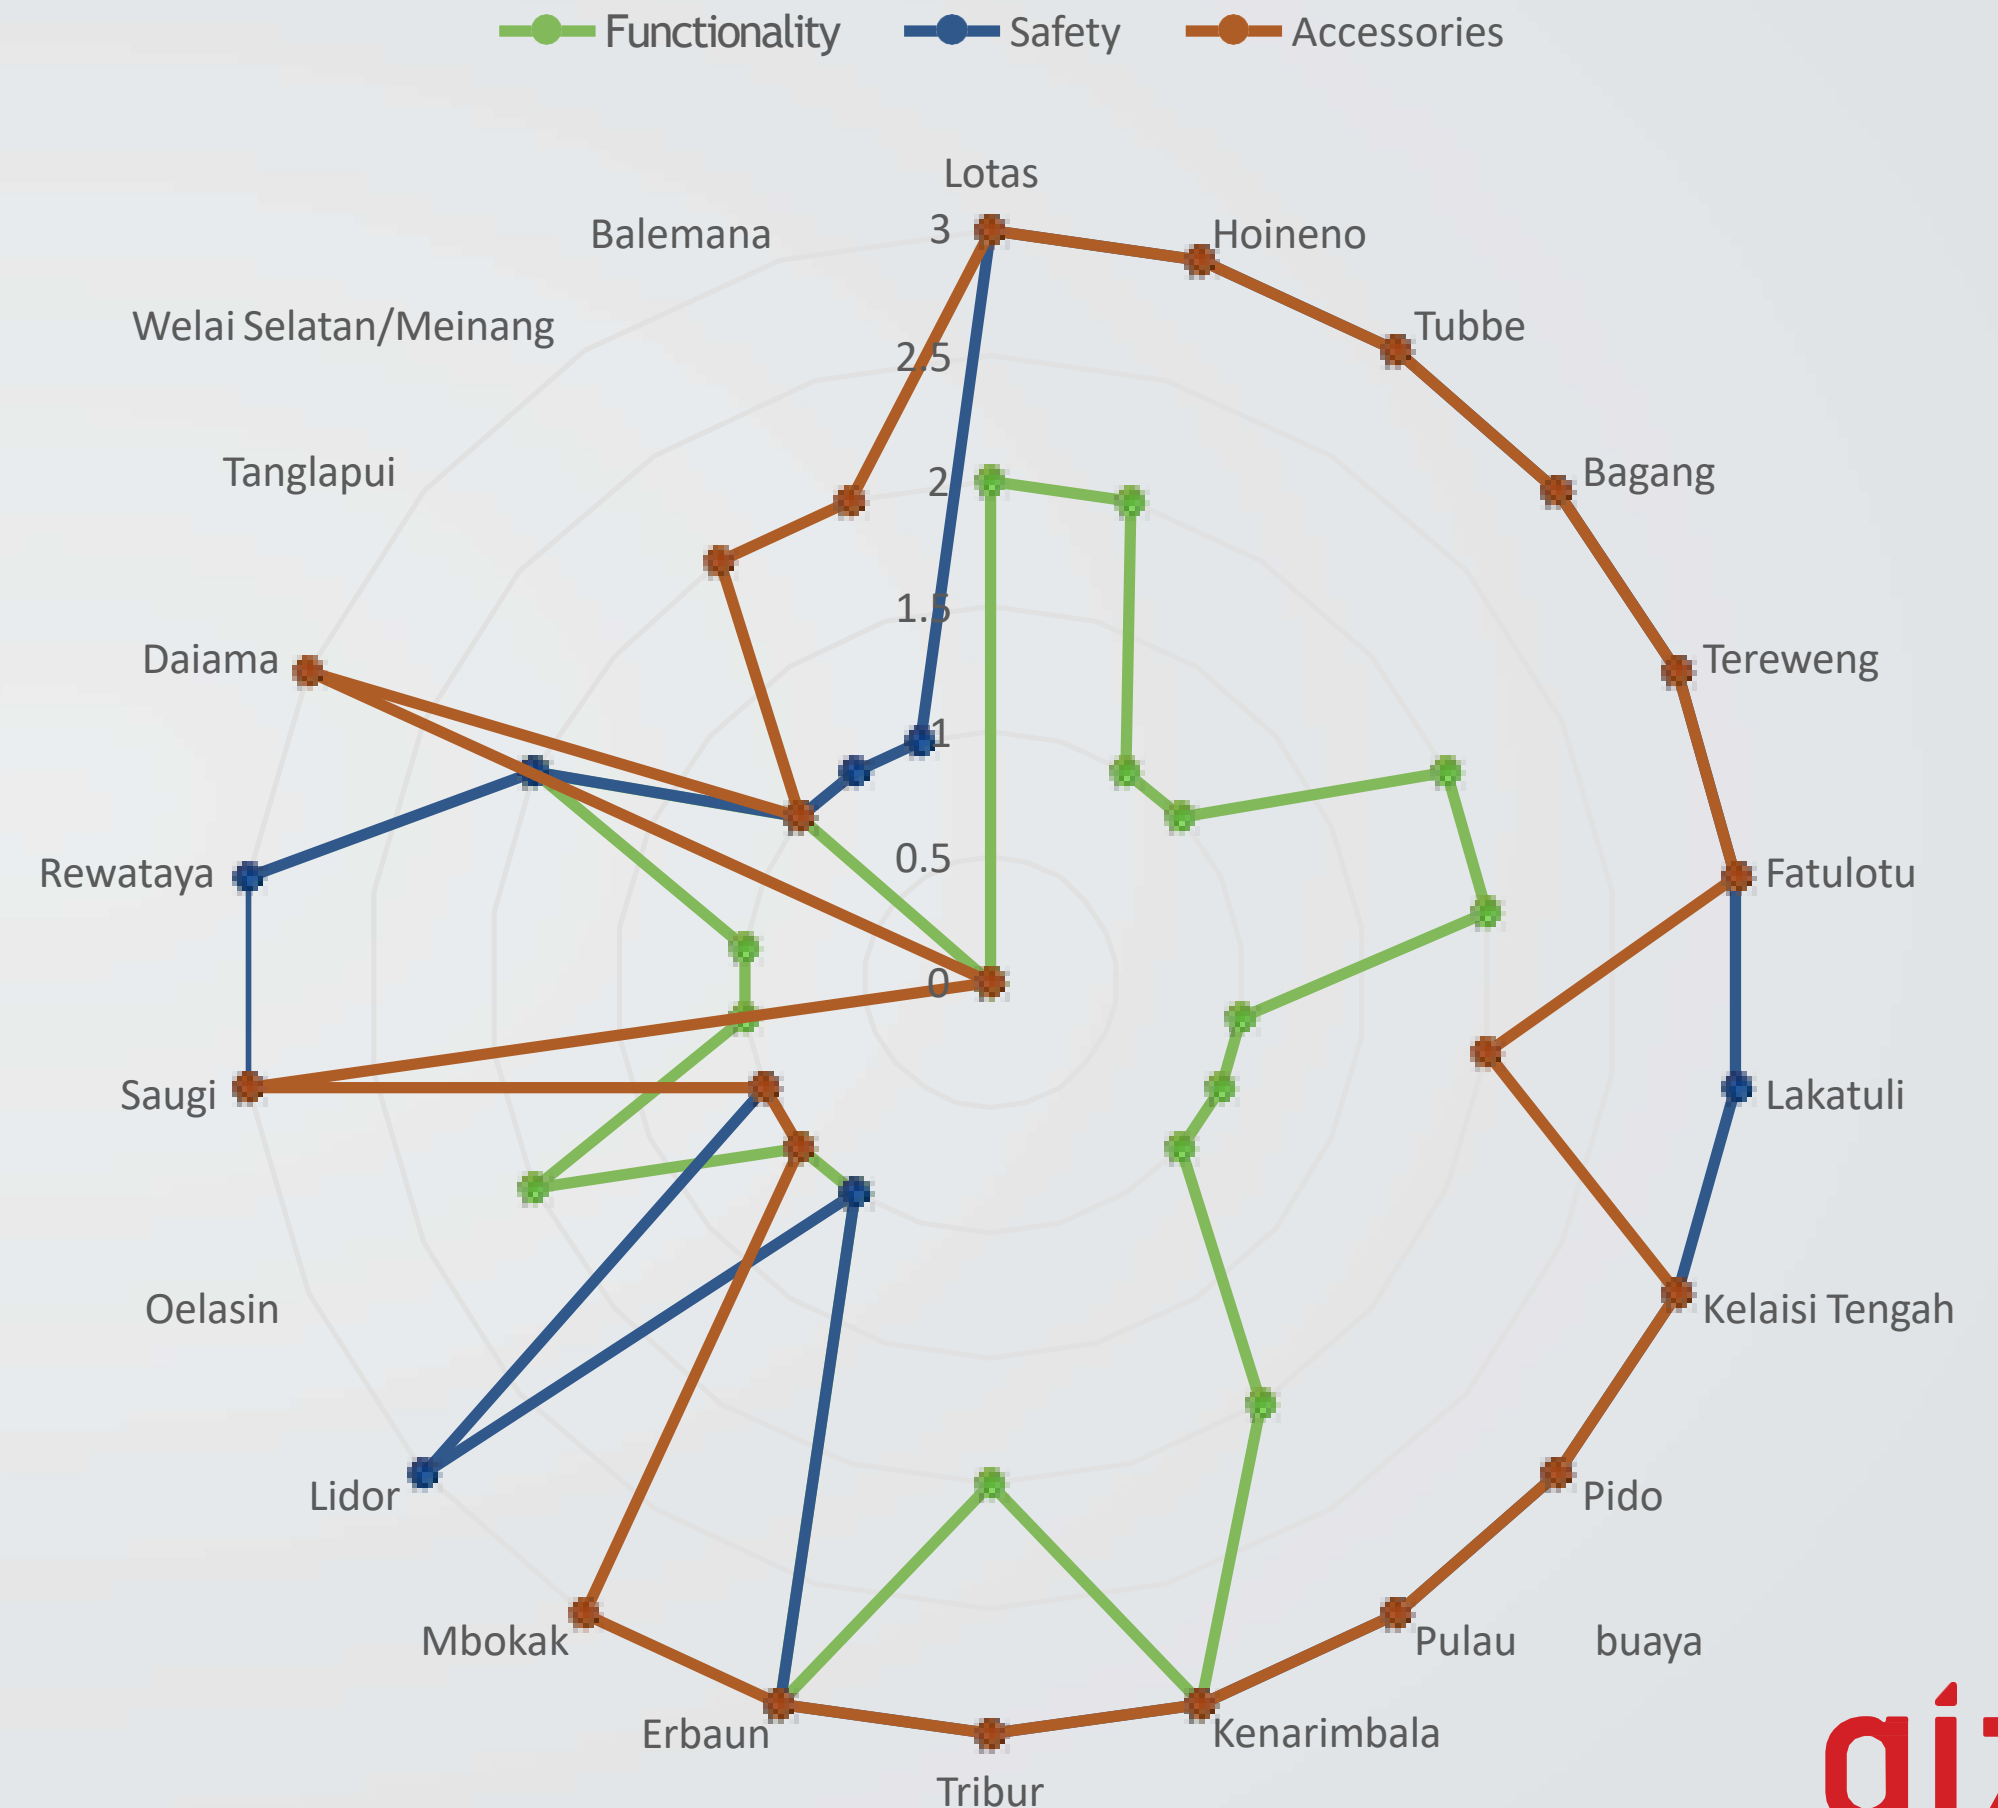
2. System performance

According to the scoring method under Step 2, values are given for each system.

- A score of 2-3 categorises a system as functional (with minor restrictions).
- Values of 0-1 classify a system as not safe to operate.

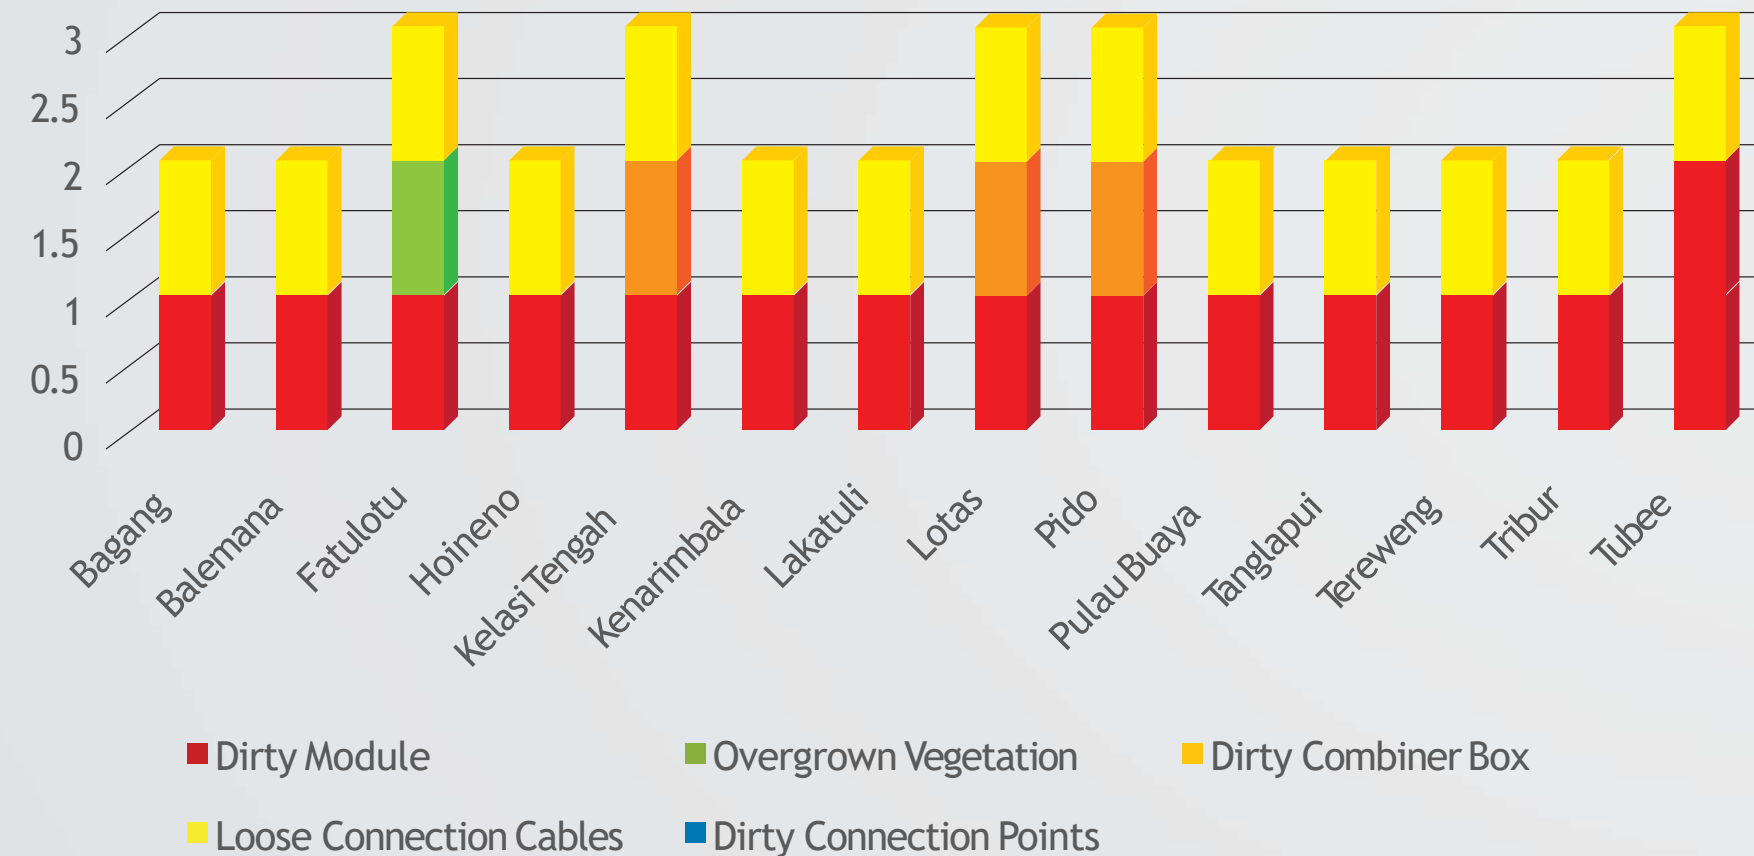
Preventive Maintenance

Despite being able to explain their job well, Preventive maintenance is hard to keep because “operator” is not their main job
